## Memorandum

**Subject: Pre-CERCLIS Screening Assessment of the Section 30 West Mine, New Mexico:**

No Further Action Under CERLCA Recommended

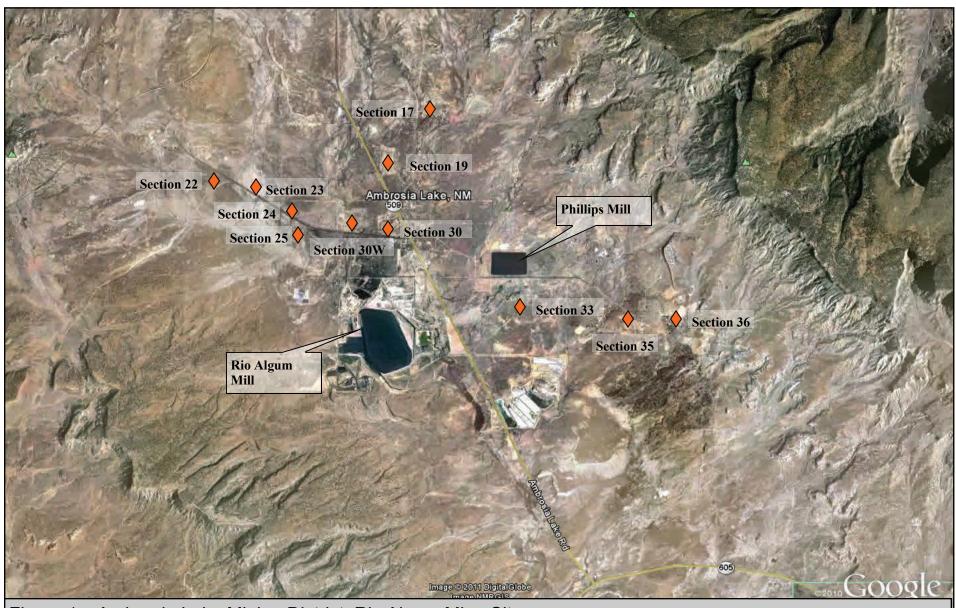
Figure 1. Ambrosia Lake Mining District, Rio Algom Mine Sites

The Section 30W mine is one of 97 legacy uranium sites identified within the Ambrosia Mining Sub-District of the Grants Mining District. It is one of 11 mines that are being addressed by Rio Algom Mining, LLC (RAML) under a discharge permit (DP-362) in accordance with the New Mexico Water Quality Control Commission (NMWQCC) Regulations [20.6.2.3000 NMAC].
